NTSB National Transportation Safety Board

Office of Aviation Safety

Thrust Reversers

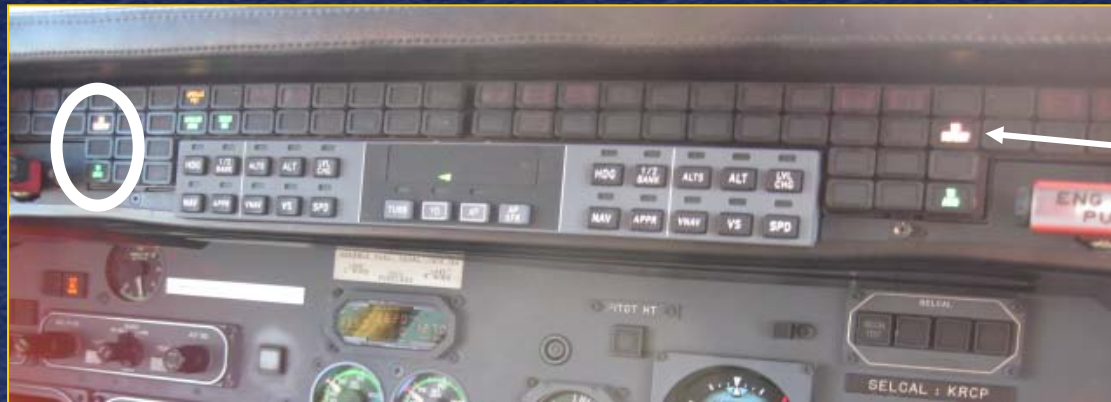
- Three small annunciator lights located on each pilot's side of forward glareshield
- TR DEPLOY light extinguished immediately

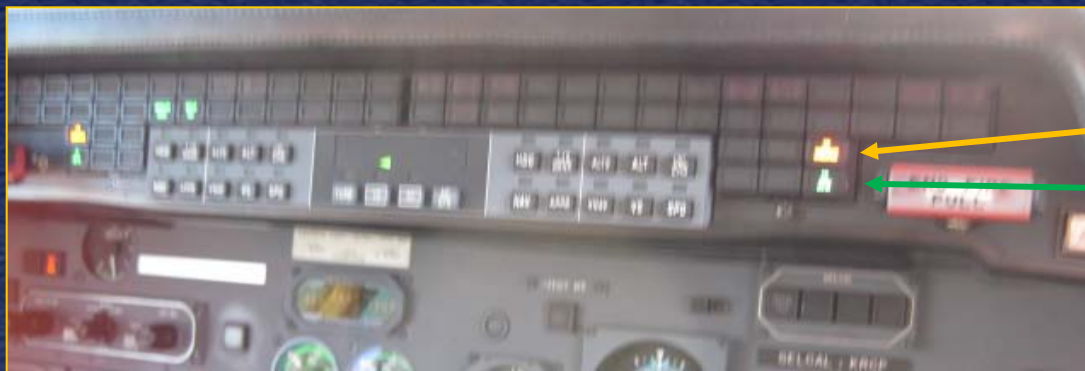
TR UNLOCK
TR ARM

- Three small annunciator lights located on each pilot's side of forward glareshield
- TR DEPLOY light extinguished immediately
- TR UNLOCK light on during transit

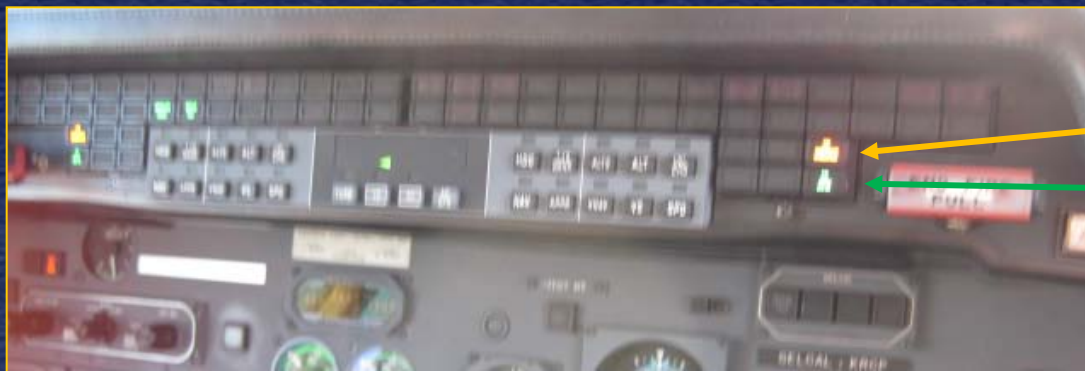
TR UNLOCK
TR ARM

- Three small annunciator lights located on each pilot's side of forward glareshield
- TR DEPLOY light extinguished immediately
- TR UNLOCK light on during transit
- TR ARM light flashed momentarily then extinguished
